OHIO RIVER BASIN
RILEY RUN, ELK COUNTY

RILEY RUN DAM
NDI No. Pa. - 386

PHASE I INSPECTION REPORT
NATIONAL DAM INSPECTION PROGRAM.

11 AUGUST 1978

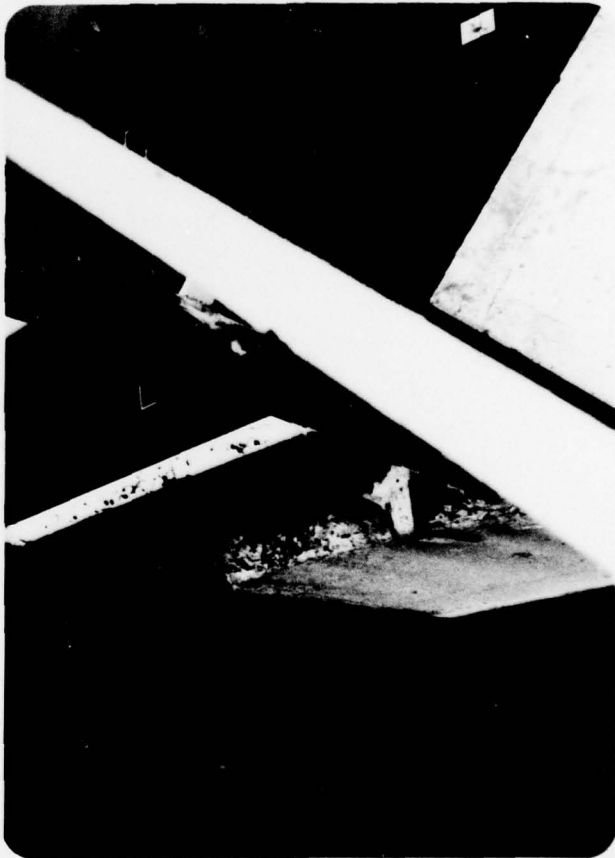
The tower, on the other hand, shows several areas of severe spalling and general concrete and steel deterioration. The reservoir level can apparently be controlled to some extent with a gate suspended by a wire rope over the intake notch.

The intake tower shows signs of severe concrete and steel deterioration. Inflow (or pool level) can apparently be controlled to a limited degree by a gate suspended from a wire rope attached to the steel framework. There are no provisions for low level inflow or drawdown should the need arise.

PHOTOGRAPH 7 Detailed view of the Riley Run outlet showing corrosion of steel grating and deterioration of the concrete surface.

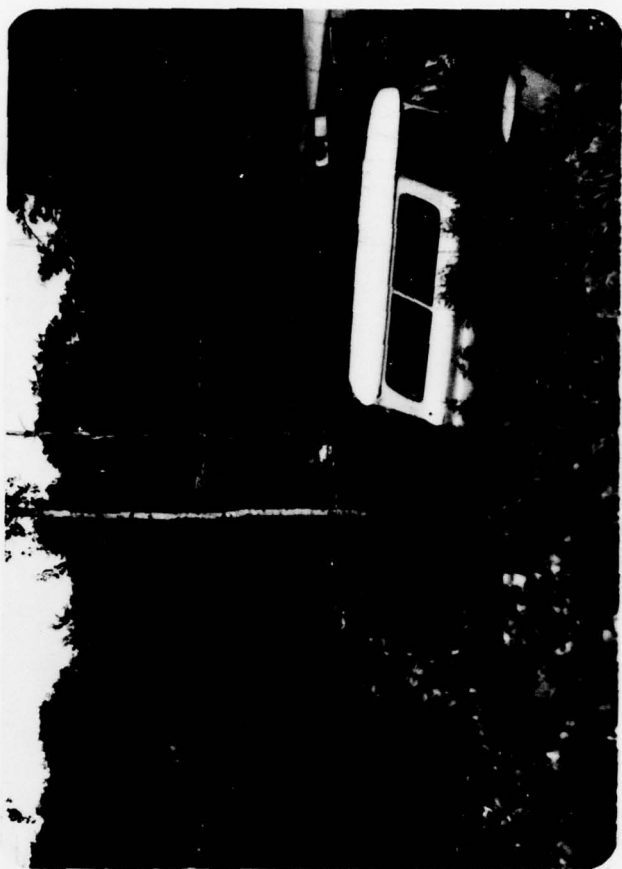
PHOTOGRAPH 10 View of the confluence of Riley Run and the Clarion River located approximately 2 miles downstream of the dam.

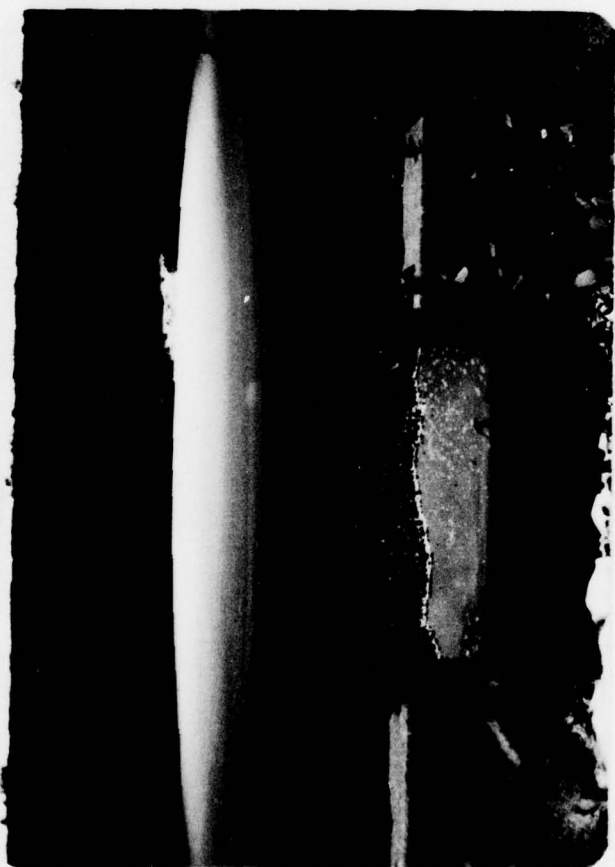
PHOTOGRAPH 9 Closeup view of the weir located on the downstream end of the stilling basin. Water passing over the weir is directed into the natural downstream drainage. The embankment is shown in the background of the photograph.
